**Flood Control Project Maintenance
Levee Inspections**

Maintenance Issue Types Only, Levee Inspection Report By Mile - Fall 2018

Reclamation District No. 1602 Del Puerto

Waterway	Bank	Unit Miles	Inspection Start/End	Inspector
Unit No. 01 San Joaquin River	Left	6.24	11/06/2018 11/06/2018	Corey Fujitani

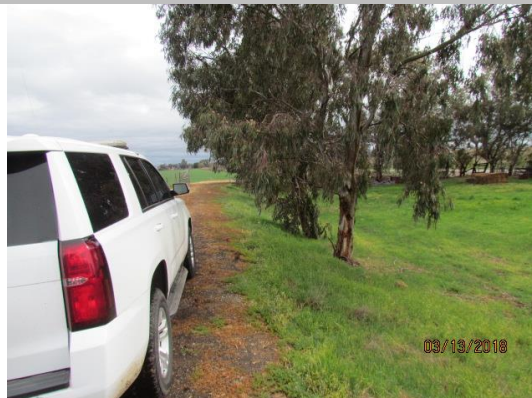
Photo 1 of 1 : FA_2018_RD1602_110_60_20180905_00032.jpg

LM Start	0.09	Rating **	M	Issue No.	60
LM End	0.11	Issue Type +	Ma	Location *	LS
Category	Earthen Levee			GPS Latitude/Longitude	
				Start	End
Item	Trim / Thin Trees			37.477161°	37.477299°
				-121.082504°	-121.082084°
DWR ID	DWR_RD1602_01_s_2018_60				
Comment Code					
T1 : Trim trees to at least five feet above ground level.					
Inspector Comment

Looking upstream at trees on landward slope.

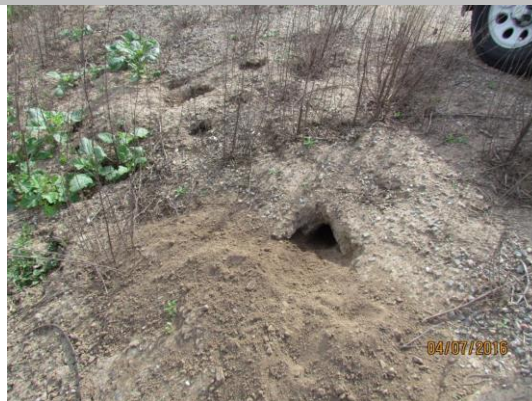
Photo 1 of 2 : FA_2018_RD1602_110_28_20180905_00008.jpg

Updated picture of the rodent hole on the waterside of the levee during spring 2016 inspection.

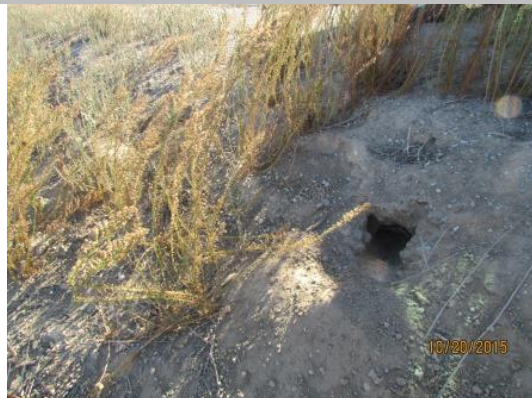
Photo 2 of 2 : FA_2018_RD1602_110_28_20180905_00009.jpg

A rodent hole was found on the waterside of the levee.

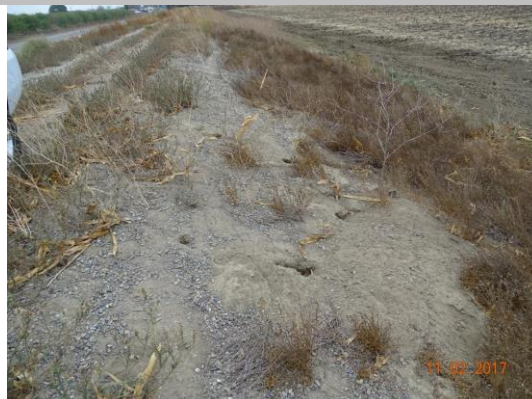
Photo 1 of 2 : FA_2018_RD1602_110_29_20180905_00010.jpg

LM Start	0.26	Rating **	M	Issue No.	29
LM End	0.26	Issue Type +	Ma	Location *	WS
Category	Earthen Levee			GPS Latitude/Longitude	
				Start	End
Item	Animal Control			37.478138 °	37.478138 °
				-121.079810 °	-121.079810 °
DWR ID	DWR_RD1602_01_f_2017_29				
Comment Code					
A3 : No rodents visible, but rodent burrows visible; need to backfill and compact or grout burrows.					
Inspector Comment

View of a rodent hole on the waterside of the levee. Fall 2017

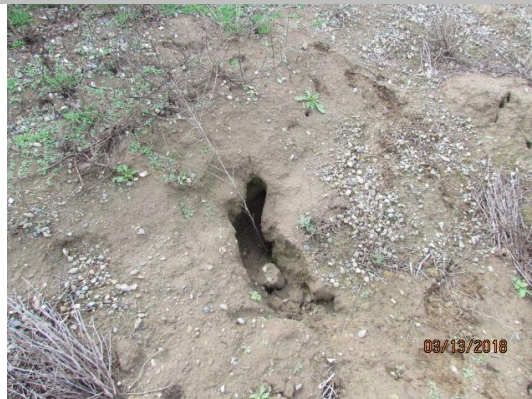
Photo 2 of 2 : FA_2018_RD1602_110_29_20180905_00011.jpg

Looking at typical rodent holes on waterward slope. (Spring 2018)

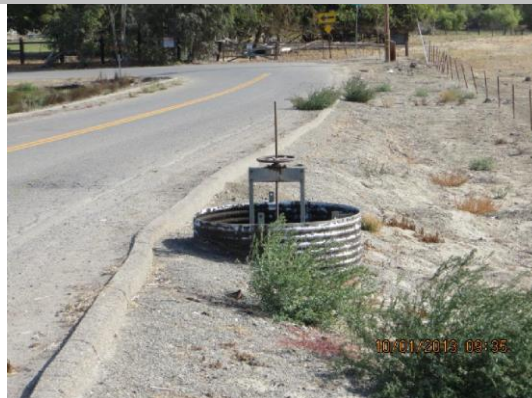
Photo 1 of 3 : UCIP_FA_2018_51325_36702.jpg

Comment Code					
Inspector Comment					
FS_ID:51325 DS_ID:20215 EP_NO: N/A Repair Type: No Action Needed Crossing Status: Found UCIP Comments: 11/18/2016 Crossing has been downgraded from Urgent to No Action Needed a cover has been added to the CMP riser. (O. Magana - DWR UCIP)10/01/2013 Open 60-inch CMP riser on WS needs lid as it's depth may be a hazard to the public. (W. Wylie - DWR UCIP) FIELD_STRUCT_DESC: 16-inch steel drainage pipe through levee, 11.3 feet below crown. Slide gate in 60-inch corrugated metal pipe (CMP) riser located on the waterside (WS). Concrete inlet is approximately 110 feet west of the levee crown or 110 feet off landside (LS) toe next to roadway. [Additional Reference(s): DWR Levee Log, 1992. USACE San Joaquin River O&M Manual Unit 13, April 1964, (HLM 0.58), Drawing No. 7-4-1784]. FS Date: 11/18/2016

60-inch CMP riser on WS shoulder.

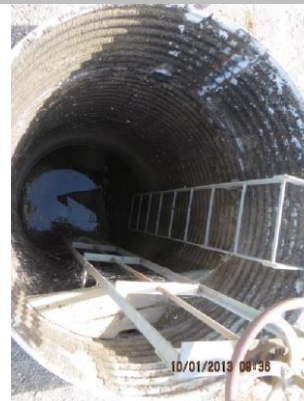
Photo 2 of 3 : UCIP_FA_2018_51325_36701.jpg

CMP riser with slide gate on WS shoulder.

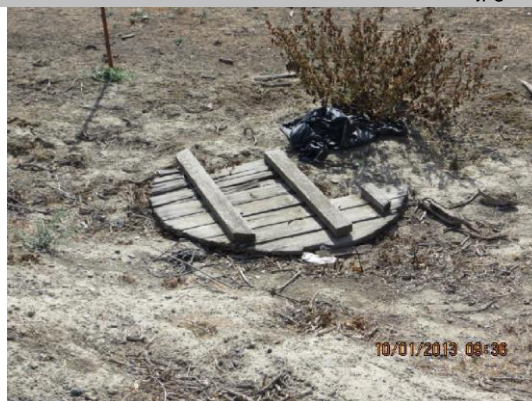
Photo 3 of 3 : UCIP_FA_2018_51325_36700.jpg

Item	DWR UCIP LMA Responsibility			37.480182 °	37.480182 °	
				-121.074765 °	-121.074765 °	
DWR ID	20215					
Comment Code						
Inspector Comment						
FS_ID:51325 DS_ID:20215 EP_NO: N/A Repair Type: No Action Needed Crossing Status: Found UCIP Comments: 11/18/2016 Crossing has been downgraded from Urgent to No Action Needed a cover has been added to the CMP riser. (O. Magana - DWR UCIP)10/01/2013 Open 60-inch CMP riser on WS needs lid as it's depth may be a hazard to the public. (W. Wylie - DWR UCIP) FIELD_STRUCT_DESC: 16-inch steel drainage pipe through levee, 11.3 feet below crown. Slide gate in 60-inch corrugated metal pipe (CMP) riser located on the waterside (WS). Concrete inlet is approximately 110 feet west of the levee crown or 110 feet off landside (LS) toe next to roadway. [Additional Reference(s): DWR Levee Log, 1992. USACE San Joaquin River O&M Manual Unit 13, April 1964, (HLM 0.58), Drawing No. 7-4-1784]. FS Date: 11/18/2016

Damaged Wooden lid on WS toe.

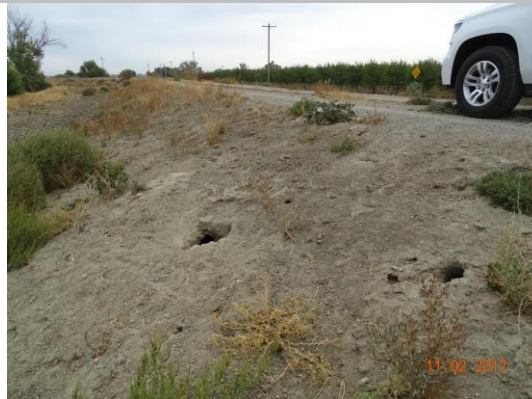
Photo 1 of 1 : FA_2018_RD1602_110_30_20180905_00012.jpg

View of rodent holes on the waterside slope of the levee. Fall 2017

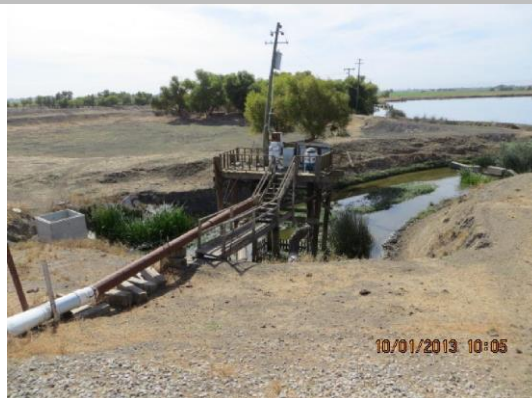
Photo 1 of 3 : UCIP_FA_2018_51636_36758.jpg

Comment Code						
Inspector Comment						
FS_ID:51636 DS_ID:20217 EP_NO: N/A Repair Type: Non-Urgent Crossing Status: Found UCIP Comments: 11/18/2016 Crossing has been downgraded from Urgent to Non-Urgent a flap gate has been added to the WS but pipe is currently not connected to pump. According to Tony Martinez, LMA representative, this crossing is currently not in use. Owner will need to coordinate with CVFPB to obtain permit. (O. Magana - DWR UCIP)10/01/2013 Appears abandoned and if so should be done so properly. Flapgate missing. (W. Wylie - DWR UCIP) FIELD_STRUCT_DESC: *ABANDONED* 1 of 2: 16-inch steel drainage pipe through levee, 17 feet below crown. Pumps on the pump platform are located on the landside (LS). Siphon breaker in 24-inch corrugated metal pipe (CMP) riser is located on the waterside (WS) shoulder. Concrete "U" headwall and flap gate are located on the WS end. [Additional Reference(s): DWR Levee Log, 1992. USACE San Joaquin River O&M Manual Unit 13, April 1964, (HLM 1.01), Drawing No. 7-4-1784]. FS Date: 11/18/2016

Pumping plant on LS toe. Pipe visible under walkway.

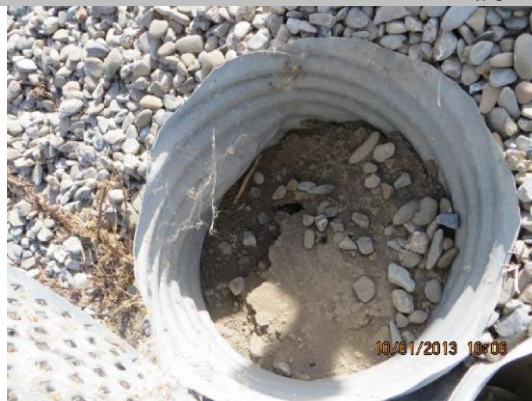
Photo 2 of 3 : UCIP_FA_2018_51637_36771.jpg

Comment Code					
Inspector Comment					
FS_ID:51637 DS_ID:20219 EP_NO: N/A Repair Type: Non-Urgent Crossing Status: Found UCIP Comments: 11/18/2016 Crossing has been downgraded from Urgent to Non-Urgent a flap gate has been added to the WS. According to Tony Martinez, LMA representative, this crossing is currently not in use. Owner will need to coordinate with CVFPB to obtain permit. (O. Magana - DWR UCIP)10/01/2013 Appears abandoned siphon breakers covered in soil and flapgate missing. (W. Wylie - DWR UCIP) FIELD_STRUCT_DESC: *ABANDONED* 2 of 2: 16-inch steel drainage pipe through levee, 17 feet below crown. Pump on pump platform located on the landside (LS). Siphon breaker in 24-inch riser located on the waterside (WS) shoulder. Concrete "U" headwall and flap gate are located on the WS end. [Additional Reference(s): DWR Levee Log, 1992. USACE San Joaquin River O&M Manual Unit 13, April 1964, (HLM 1.01), Drawing No. 7-4-1784]. FS Date: 11/18/2016

Siphon breaker covered in soil at CMP riser on WS shoulder.

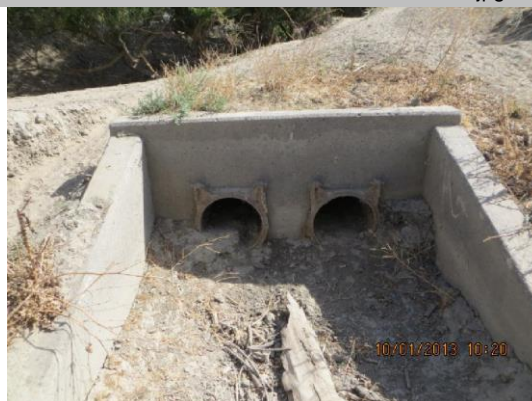
Photo 3 of 3 : UCIP_FA_2018_51637_36770.jpg

Comment Code						
Inspector Comment						
FS_ID:51637 DS_ID:20219 EP_NO: N/A Repair Type: Non-Urgent Crossing Status: Found UCIP Comments: 11/18/2016 Crossing has been downgraded from Urgent to Non-Urgent a flap gate has been added to the WS. According to Tony Martinez, LMA representative, this crossing is currently not in use. Owner will need to coordinate with CVFPB to obtain permit. (O. Magana - DWR UCIP)10/01/2013 Appears abandoned siphon breakers covered in soil and flapgate missing. (W. Wylie - DWR UCIP) FIELD_STRUCT_DESC: *ABANDONED* 2 of 2: 16-inch steel drainage pipe through levee, 17 feet below crown. Pump on pump platform located on the landside (LS). Siphon breaker in 24-inch riser located on the waterside (WS) shoulder. Concrete "U" headwall and flap gate are located on the WS end. [Additional Reference(s): DWR Levee Log, 1992. USACE San Joaquin River O&M Manual Unit 13, April 1964, (HLM 1.01), Drawing No. 7-4-1784]. FS Date: 11/18/2016

Concrete headwall on WS toe with missing flapgate.

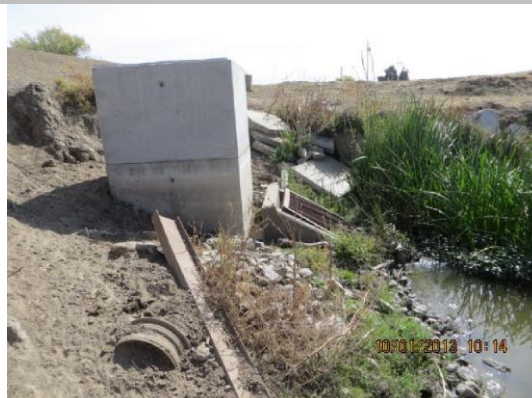
Photo 1 of 3 : UCIP_FA_2018_53521_36786.jpg

UCIP Comments: 10/19/2018 Pipe remains the same. WS concrete headwall is still detached with vertical erosion on the WS slope. Dense vegetation along pipe alignment made it difficult to inspect levee slopes and identify any potential issues present at this site. Recommend clearing vegetation along pipe alignment to be able to conduct a proper UCIP inspection. This crossing is part of DWR's Flood System Repair Project (FSRP) and Deferred Maintenance Project (DMP). Crossing will be monitored to identify progress of erosion on the WS slope. Crossing remains Urgent due to the detachment of the concrete wall and vertical cut on the WS. (O. Magana - DWR UCIP)11/18/2016 Same as previous inspection headwall on the WS toe has separated from pipe and flap gate is still missing. Erosion around concrete headwall and undermined WS slope are visible from WS. The slope undermined appears to have progressed but no photos were taken due to the dense vegetation covering area. According to Tony Martinez, LMA representative, the WS concrete headwall has been detached since 2008/2009. LMA has been in contact with CVFPB, DWR, and USACE regarding this site. (O. Magana - DWR UCIP)10/01/2013 Headwall on WS toe separated from pipe. Erosion around concrete headwall and undermined at WS toe. Flap gate missing from WS toe headwall. (W. Wylie - DWR UCIP)

Grated inlet and 5'X5' concrete box on LS toe.

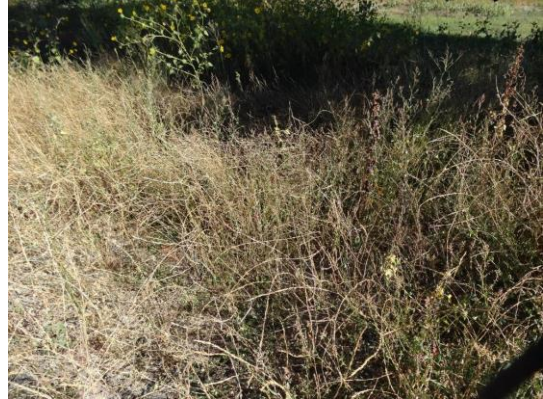
Photo 1 of 4 : FA_2018_RD1602_110_2_20180905_00001.jpg

Close view of the erosion. The erosion is covered by dense vegetation at the site.

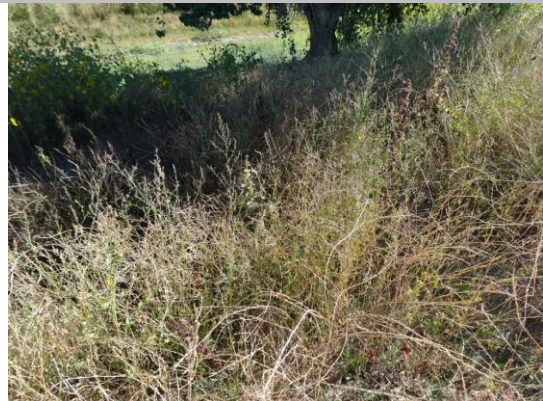
Photo 2 of 4 : FA_2018_RD1602_110_2_20180905_00002.jpg

Close view of the erosion.

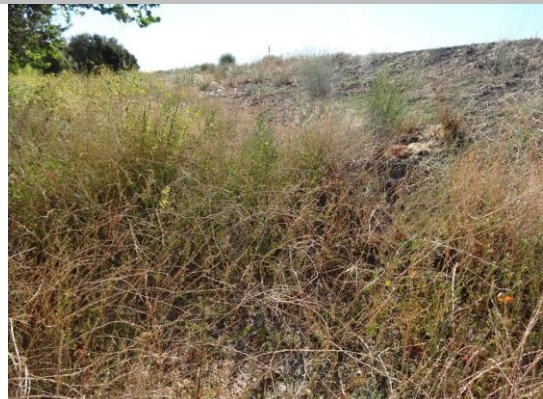
Photo 3 of 4 : FA_2018_RD1602_110_2_20180905_00003.jpg

Looking up at the erosion from the levee toe.

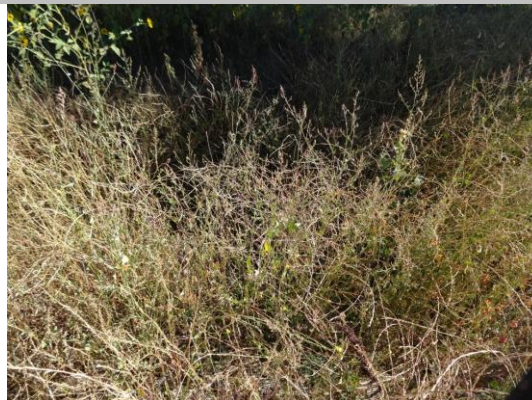
Photo 4 of 4 : FA_2018_RD1602_110_2_20180905_00004.jpg

Close view of the erosion.

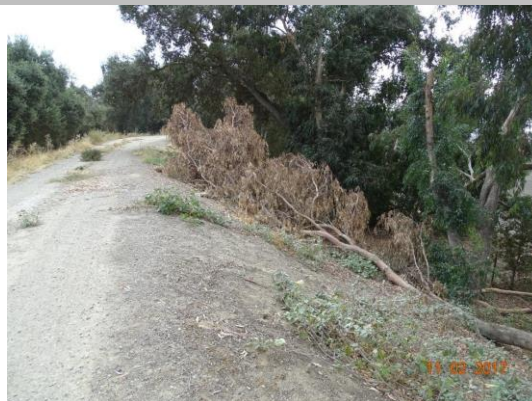
Photo 1 of 1 : FA_2018_RD1602_110_33_20180905_00013.jpg

View of prunings on the landside of the levee.

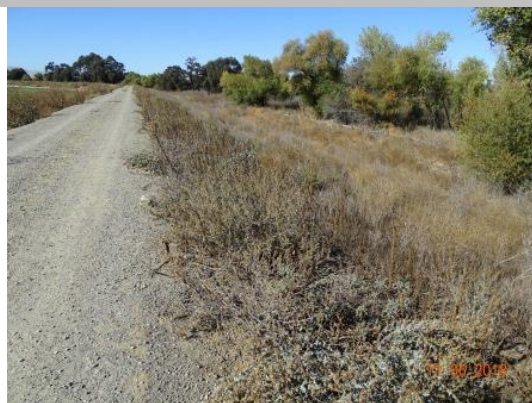
Photo 1 of 1 : FA_2018_RD1602_110_100_20181109_00106.jpg

dense brush along waterside shoulder and slope. (Fall 2018)

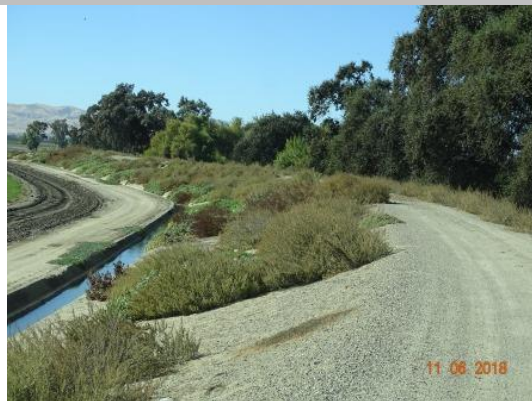
Photo 1 of 1 : FA_2018_RD1602_110_99_20181109_00109.jpg

View of dense brush on landside slope. (Fall 2018)

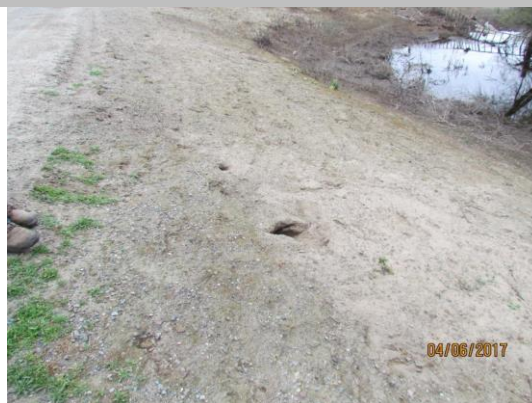
Photo 1 of 1 : FA_2018_RD1602_110_81_20180905_00050.jpg

View of a rodent hole on the waterside slope of the levee.

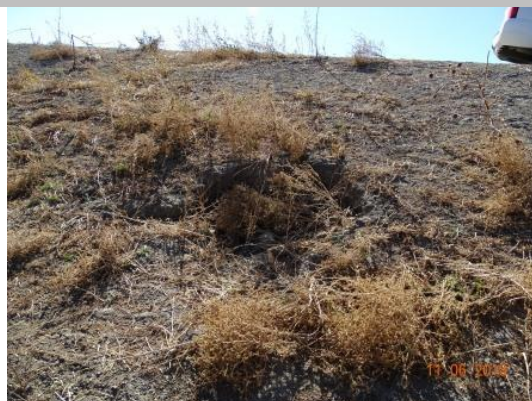
Photo 1 of 2 : FA_2018_RD1602_110_98_20181109_00111.jpg

erosion at waterside toe. (Fall 2018)

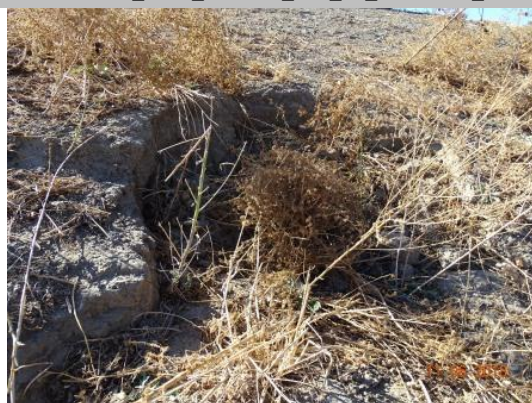
Photo 2 of 2 : FA_2018_RD1602_110_98_20181109_00110.jpg

close up view of erosion at toe. (Fall 2018)

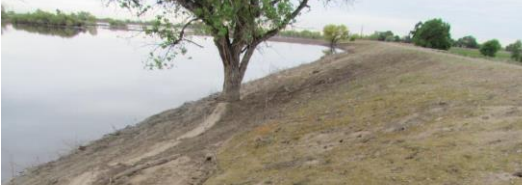
Photo 1 of 1 : FA_2018_RD1602_110_49_20180905_00023.jpg

View of rodent holes on the waterside slope of the levee. Spring 2017

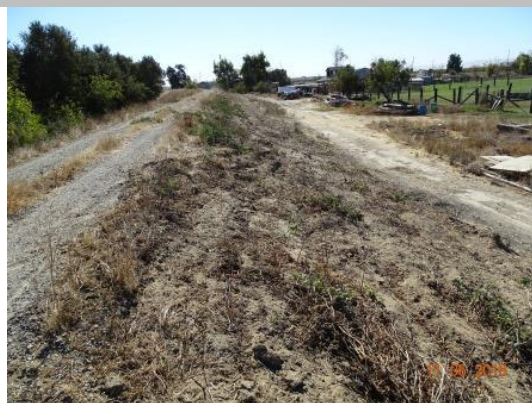
Photo 1 of 2 : FA_2018_RD1602_110_89_20181109_00113.jpg

LM Start	5.08	Rating **	M	Issue No.	89
LM End	5.13	Issue Type +	Ma	Location *	LS
Category	Earthen Levee			GPS Latitude/Longitude	
				Start	End
Item	Slope Stability			37.438249 °	°
				-121.037100 °	°
DWR ID	DWR_RD1602_01_f _ 2018_89				
Comment Code					
S3 : Repair the levee slope damaged by vehicle traffic and prevent access where possible.					
Inspector Comment					
damage to slope appears to be from vehicle traffic

View along landside slope looking upstream. (Fall 2018)

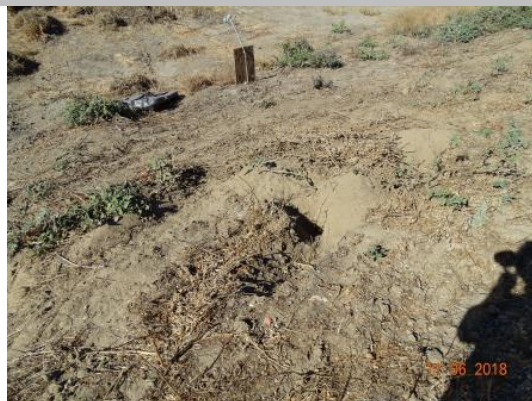
Photo 2 of 2 : FA_2018_RD1602_110_89_20181109_00114.jpg

Upclose view of some of the damage to slope. (Fall 2018)

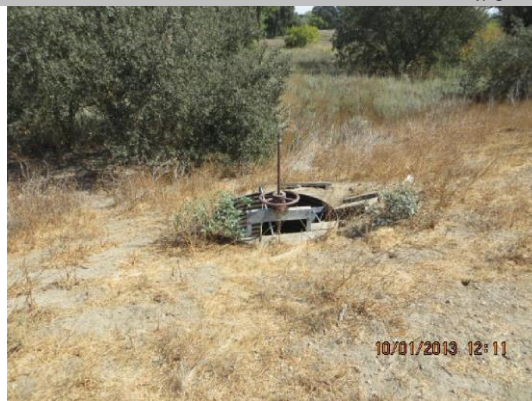
Photo 1 of 3 : UCIP_FA_2018_51336_36822.jpg

UCIP Comments: 11/18/2016 Same as previous inspection soil and debris prevent flap gate from properly functioning and slide gate won't close due to sediment build up. Crossing has been downgraded from Urgent to Non-Urgent due to no pipe or levee integrity issues observed during the site visit. Need to contact owner to determine status of crossing. If crossing is no longer in use owner will need to coordinate with CVFPB to properly abandon or remove according to Title 23 requirements. (O. Magana - DWR UCIP)10/01/2013 Soil and debris prevent flapgate from proper function. Slide gate won't close completely due to sediment buildup. CMP riser needs cover. (W. Wylie - DWR UCIP)

Slide gate in CMP riser on WS slope. Outlet visible under tree in background.

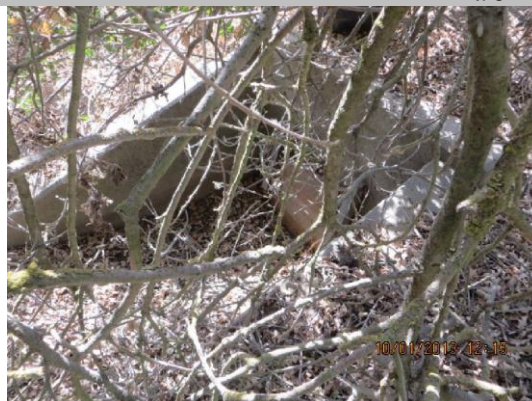
Photo 2 of 3 : UCIP_FA_2018_51336_36821.jpg

Flapgate in Concrete headwall on WS toe under tree.

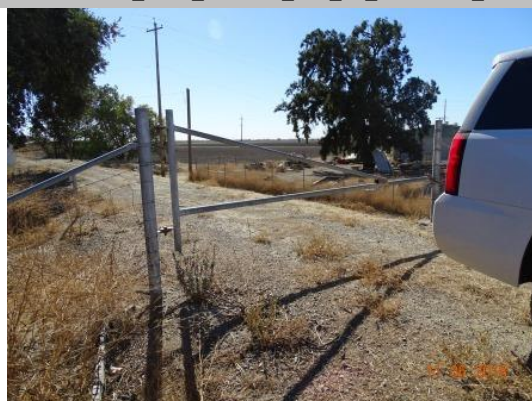
Photo 1 of 1 : FA_2018_RD1602_110_40_20181109_00115.jpg

DWR and LMA do not have keys for locks on gate. (Fall 2018)

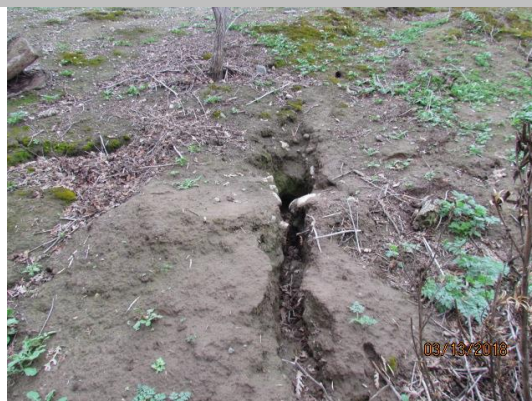
Photo 1 of 1 : FA_2018_RD1602_110_52_20180905_00026.jpg

Looking at rodent hole and erosion around rodent hole on waterward slope.

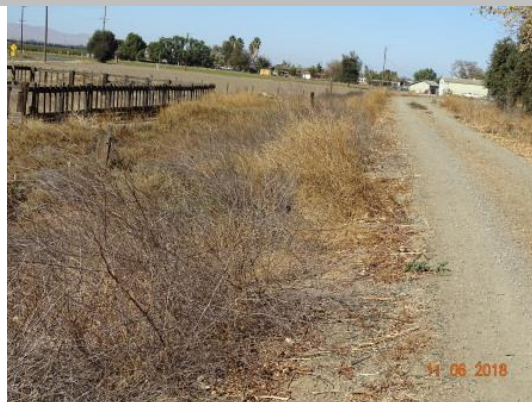
Photo 1 of 1 : FA_2018_RD1602_110_38_20181109_00116.jpg

dense brush on landside slope and toe. (Fall 2018)

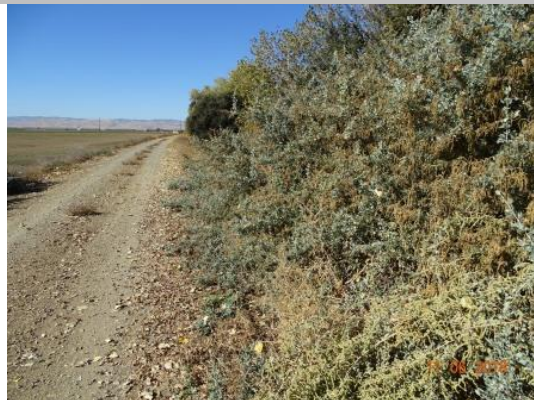
Photo 1 of 2 : FA_2018_RD1602_110_37_20181109_00117.jpg

Large bush on levee shoulder. (Fall 2018)

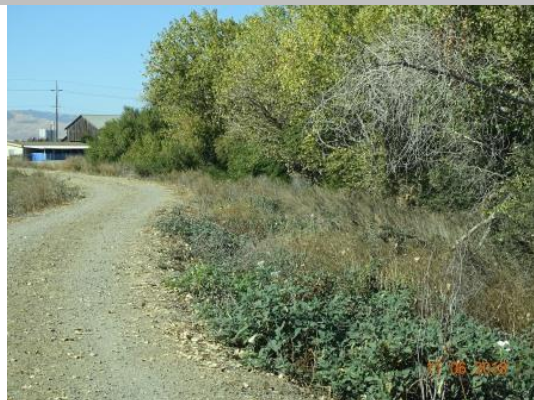
Photo 2 of 2 : FA_2018_RD1602_110_37_20181109_00118.jpg

wild growth on waterside slope (Fall 2018)

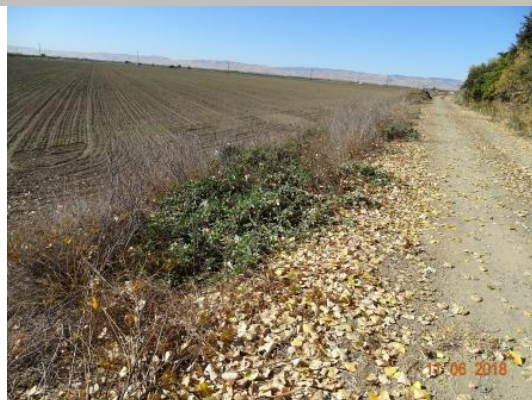
Photo 1 of 1 : FA_2018_RD1602_110_27_20181109_00119.jpg

brush blocking view of landside slope. (Fall 2018)

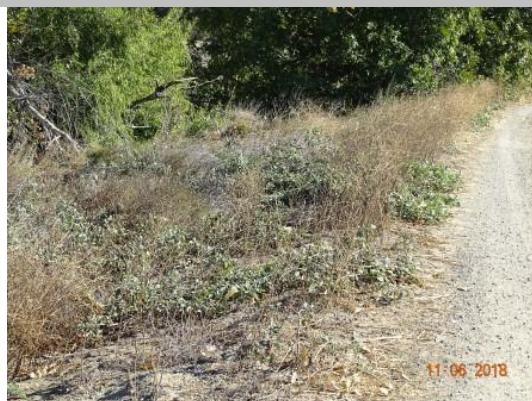
Photo 1 of 2 : FA_2018_RD1602_110_75_20181109_00121.jpg

dense vegetation on waterside slope. (Fall 2018)

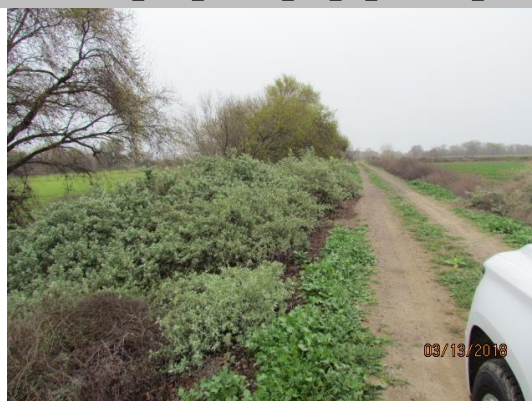
Photo 2 of 2 : FA_2018_RD1602_110_75_20180905_00046.jpg

Looking at upstream at dense vegetation on waterward slope. (Spring 2018)

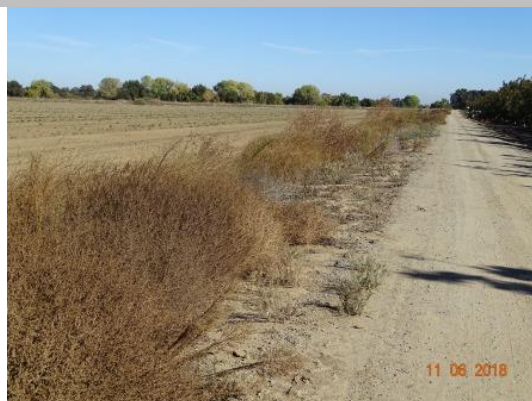
Photo 1 of 2 : FA_2018_RD1602_110_61_20181109_00122.jpg

View of vegetation on landside shoulder and slope. (Fall 2018)

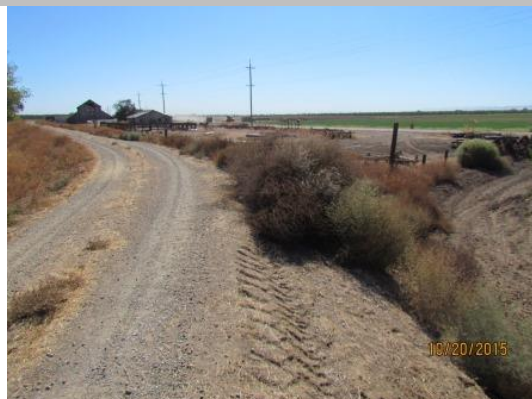
Photo 2 of 2 : FA_2018_RD1602_110_61_20180905_00033.jpg

Vegetation was obstructing the view of the landside of the levee.

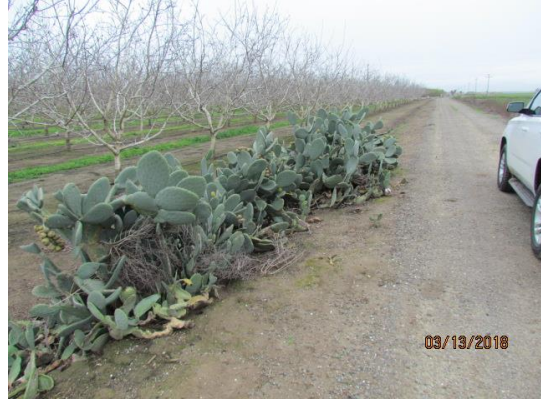
Photo 1 of 1 : FA_2018_RD1602_110_86_20180905_00056.jpg

Looking south at dense cactus on waterward slope.
